# **Quartzite**

## **Watershed Scale Ecosystem Analysis**

### Ecosystem Analysis Report

December 1998

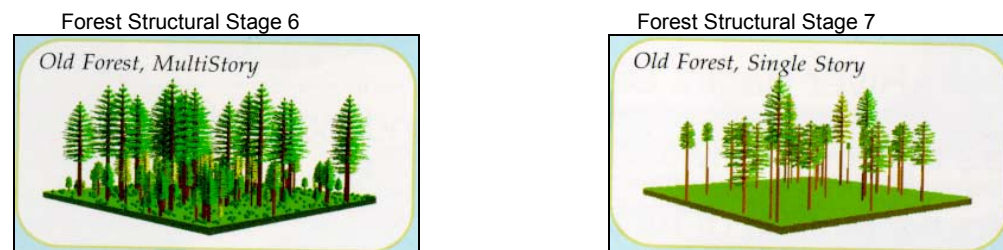
**Multi-stratum with Large Trees (Stage 6).** These late and old stands contain two or more cohorts of trees, and trees of all sizes are present. The overstory canopy is discontinuous, and dominated by large trees.
